CAPISTRANO BAY DISTRICT  
AGENDA REPORT  
*March Meeting held on April 2, 2019*

## ITEM 9b

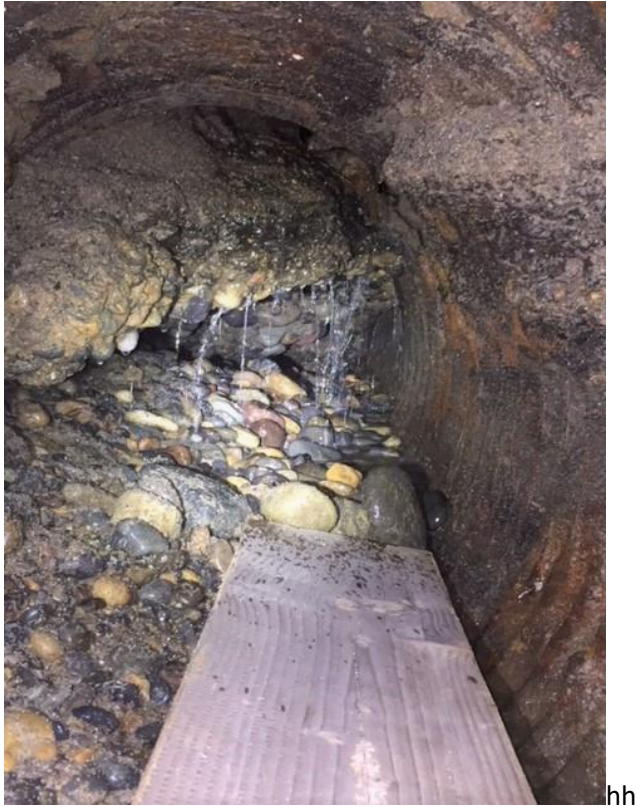
### Obstructed Storm Drain at 35595

Over the years, this particular storm drain has flowed well during heavy rain periods. However, with this past few years of limited winter rainfall, this drain has become clogged with a mass of beach sand, gravel and small beach rocks, at a point about 22 feet up into the pipe from the beach end. In a typical wet winter, there is enough rainfall to wash out our drain pipes and leave them relatively clean for the next season. It is believed that due to past drought

conditions, the normal debris that gets washed into the pipes from wave runup, was never washed out and as a result, was left to dry out and become hardened, similar to soft concrete.

In the photo above you can see the rock debris in the bottom of the pipe plus there is a large mass of concrete in the top half that is thought to be the cause of all the debris getting trapped in the pipe. It is not known how the concrete made its way into the pipe but it is suspected that during patio construction above it may have leaked in through an opening somehow when footings were being poured.

The only method of breaking up this mass of material is to batter it with a long chisel-type tool plus the use of hydro jetting. Between the two methods, we have been able to loosen up much of the debris and extract it out of the pipe. This is a slow process and can only be done during our lower monthly high tides (quarter moon phases) where we can get out there and work all day without being washed off the beach at high tide.

Over the next 30 days it is expected that the rocky material can be loosened and removed to restore the pipe to its normal function. However, the mass of concrete in the top half of the pipe is going to be more of a challenge as it is rock solid and will not break up. To actually remove this obstruction, the pipe would have to be excavated and the patio and deck above would have to be removed and rebuilt.
